**NTSB** National Transportation Safety Board

*Office of Research and Engineering*

# **Finite Element Analysis**

Carl R. Schultheisz

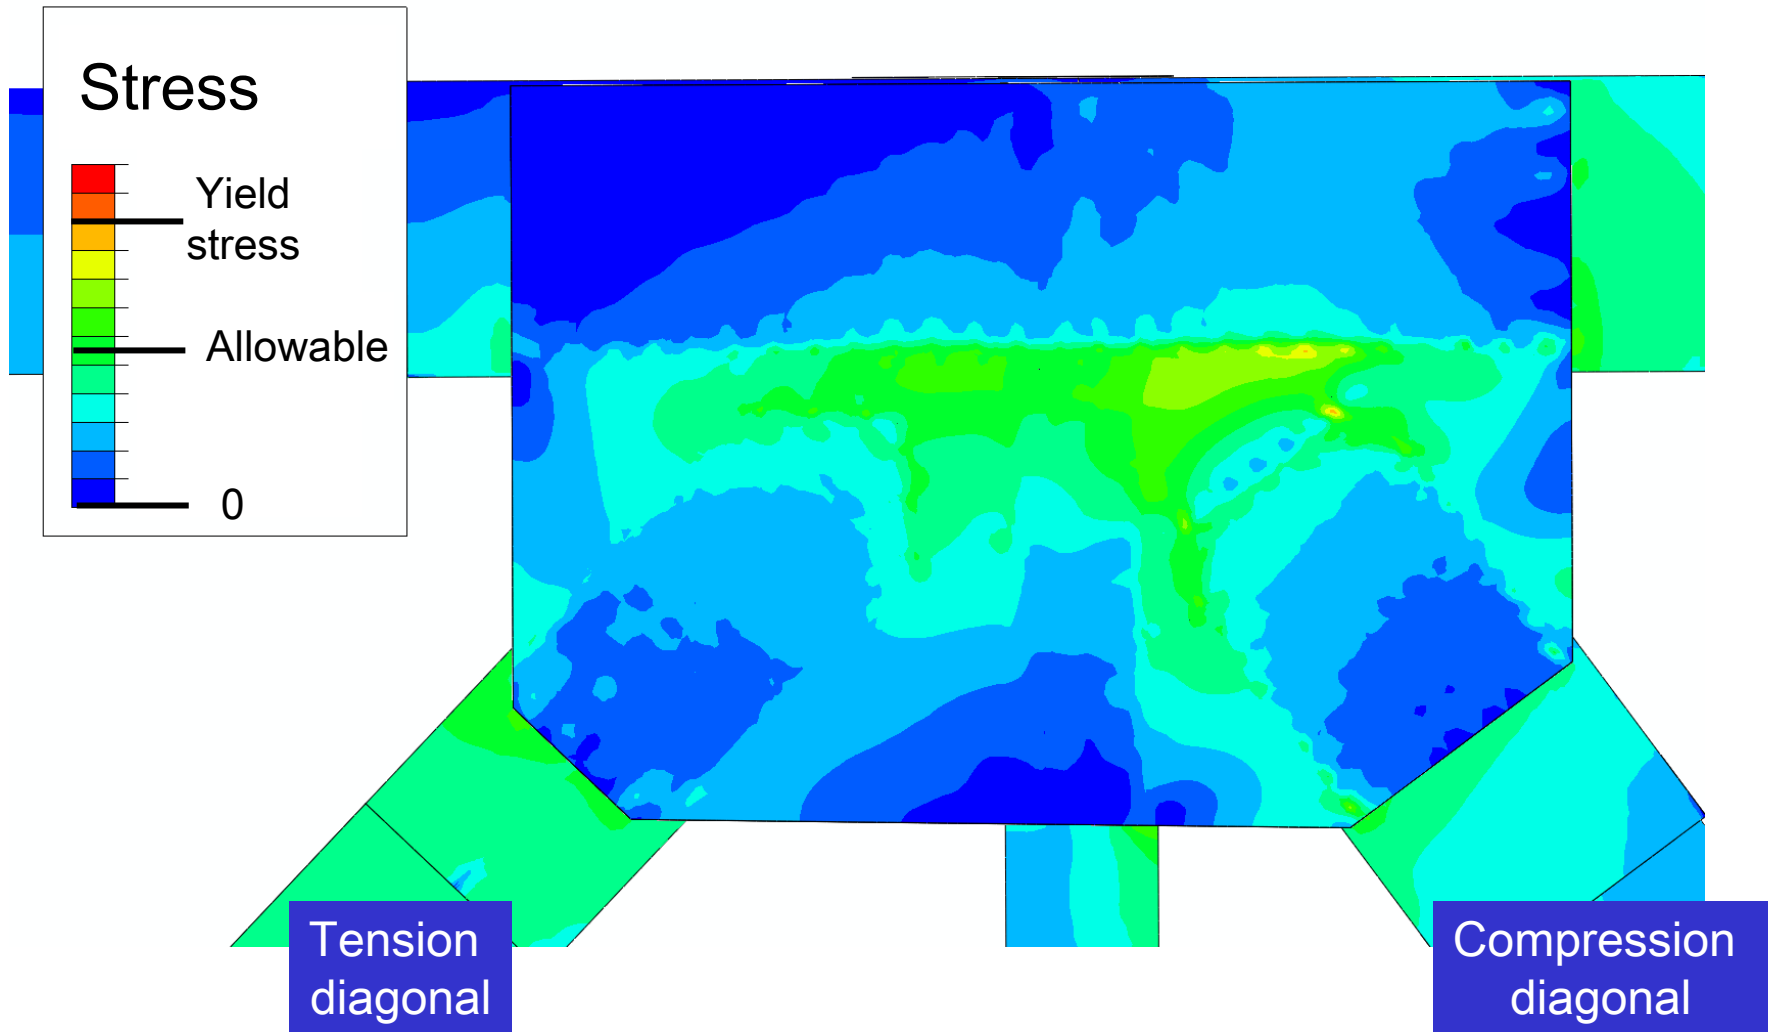
# Accident Loads on 1-Inch-Thick Gusset Plates

- Collapse began at node U10W when highly stressed gusset plates were unable to prevent unstable lateral shift of upper end of highly loaded compression diagonal
- Gusset plates meeting AASHTO specifications would have safely supported loads on bridge at time of accident
- Bowed gusset plates reduced load necessary to trigger instability and resulted in lateral shift to outside of bridge, consistent with physical observations

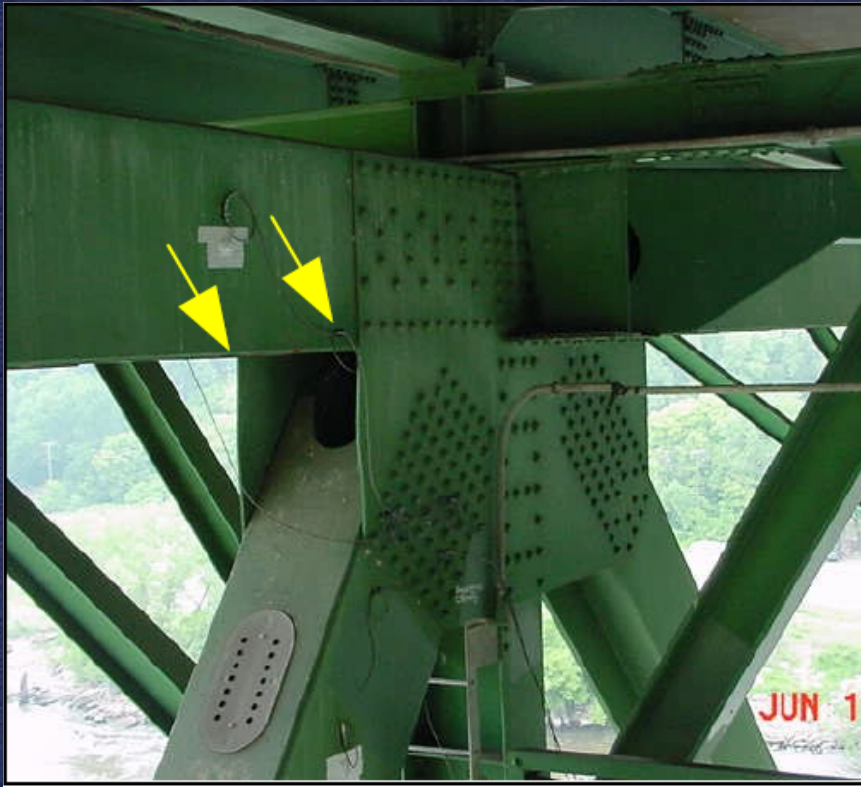
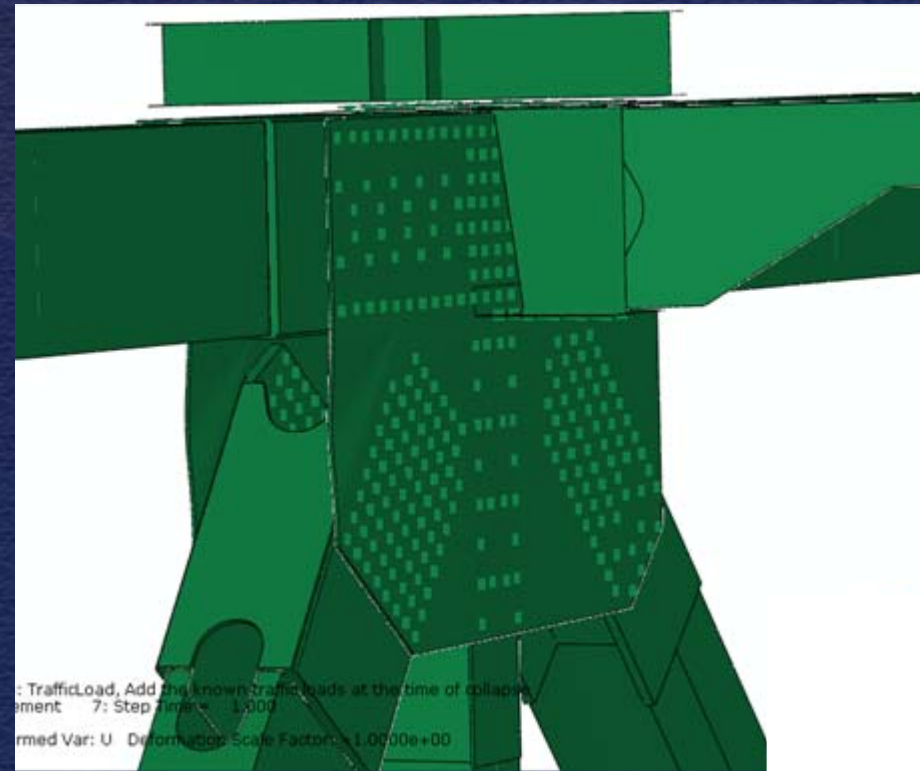
# Bowed U10 Gusset Plates

# Bowed Gusset Plates

- Reduced load necessary to trigger instability
- Upper end of the compression diagonal shifted to the outside of the bridge, consistent with physical observations
- A symptom of the inadequate capacity of the U10 gusset plates
- Distortion such as bowing should be identified and evaluated

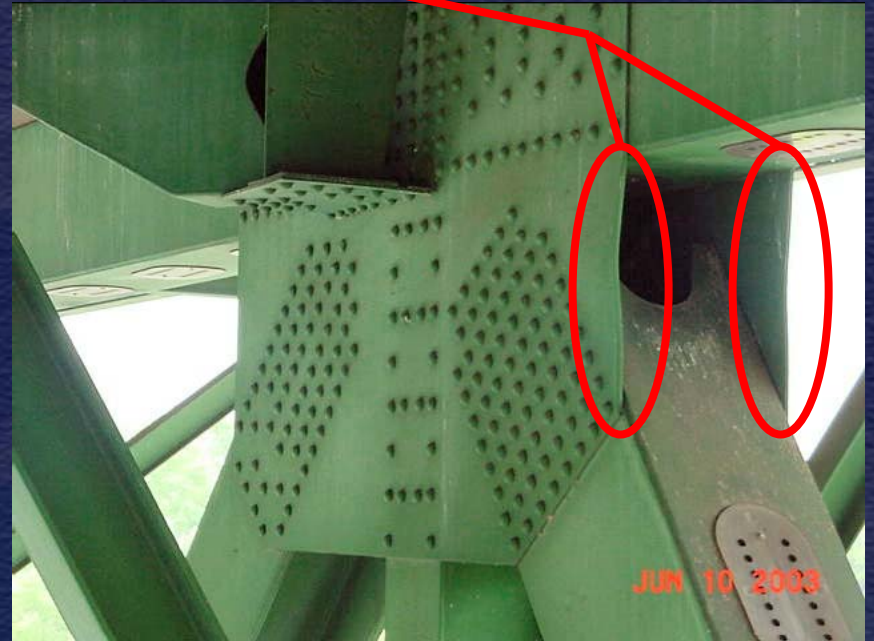
# Edge Stiffeners on U10 Gusset Plate

Edge stiffeners would not prevent gusset plate yielding

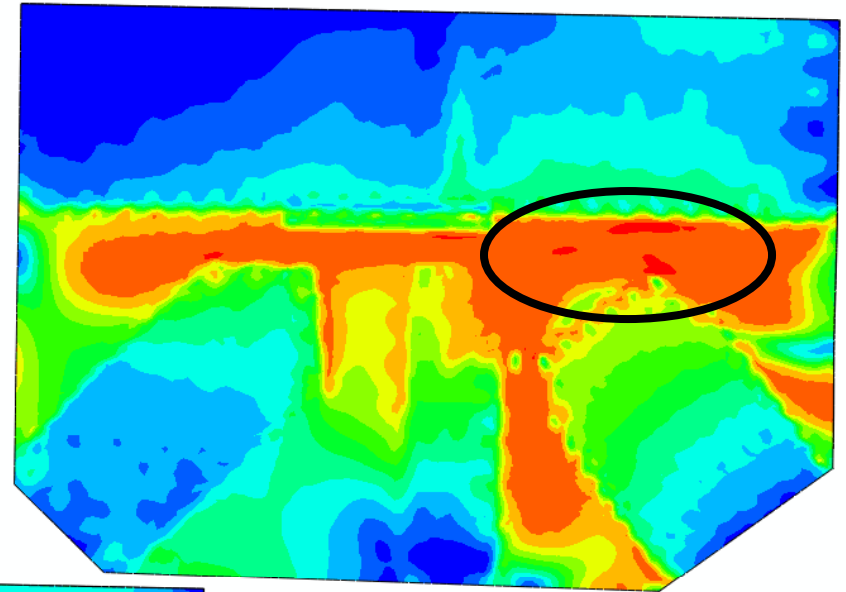
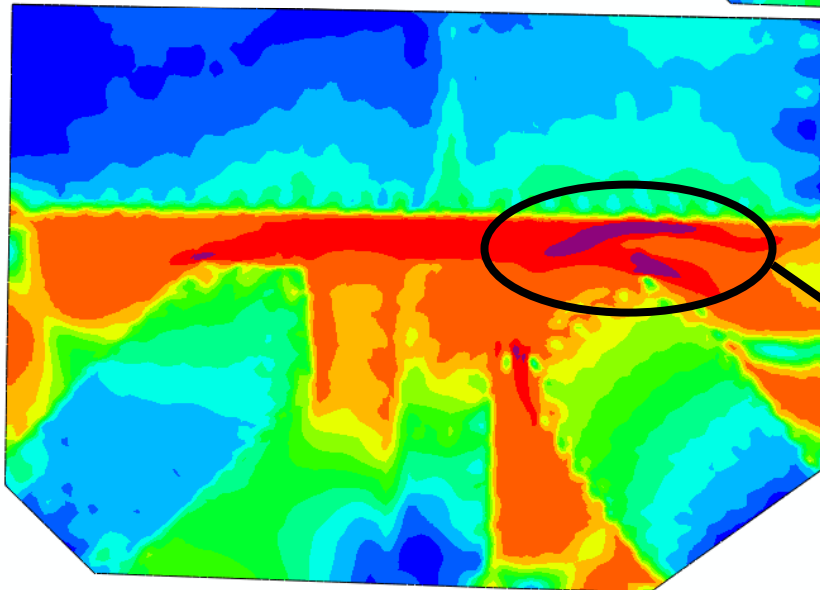
# U10 West and U10 East

U10 West

Has higher stress  
at the time of the  
accident

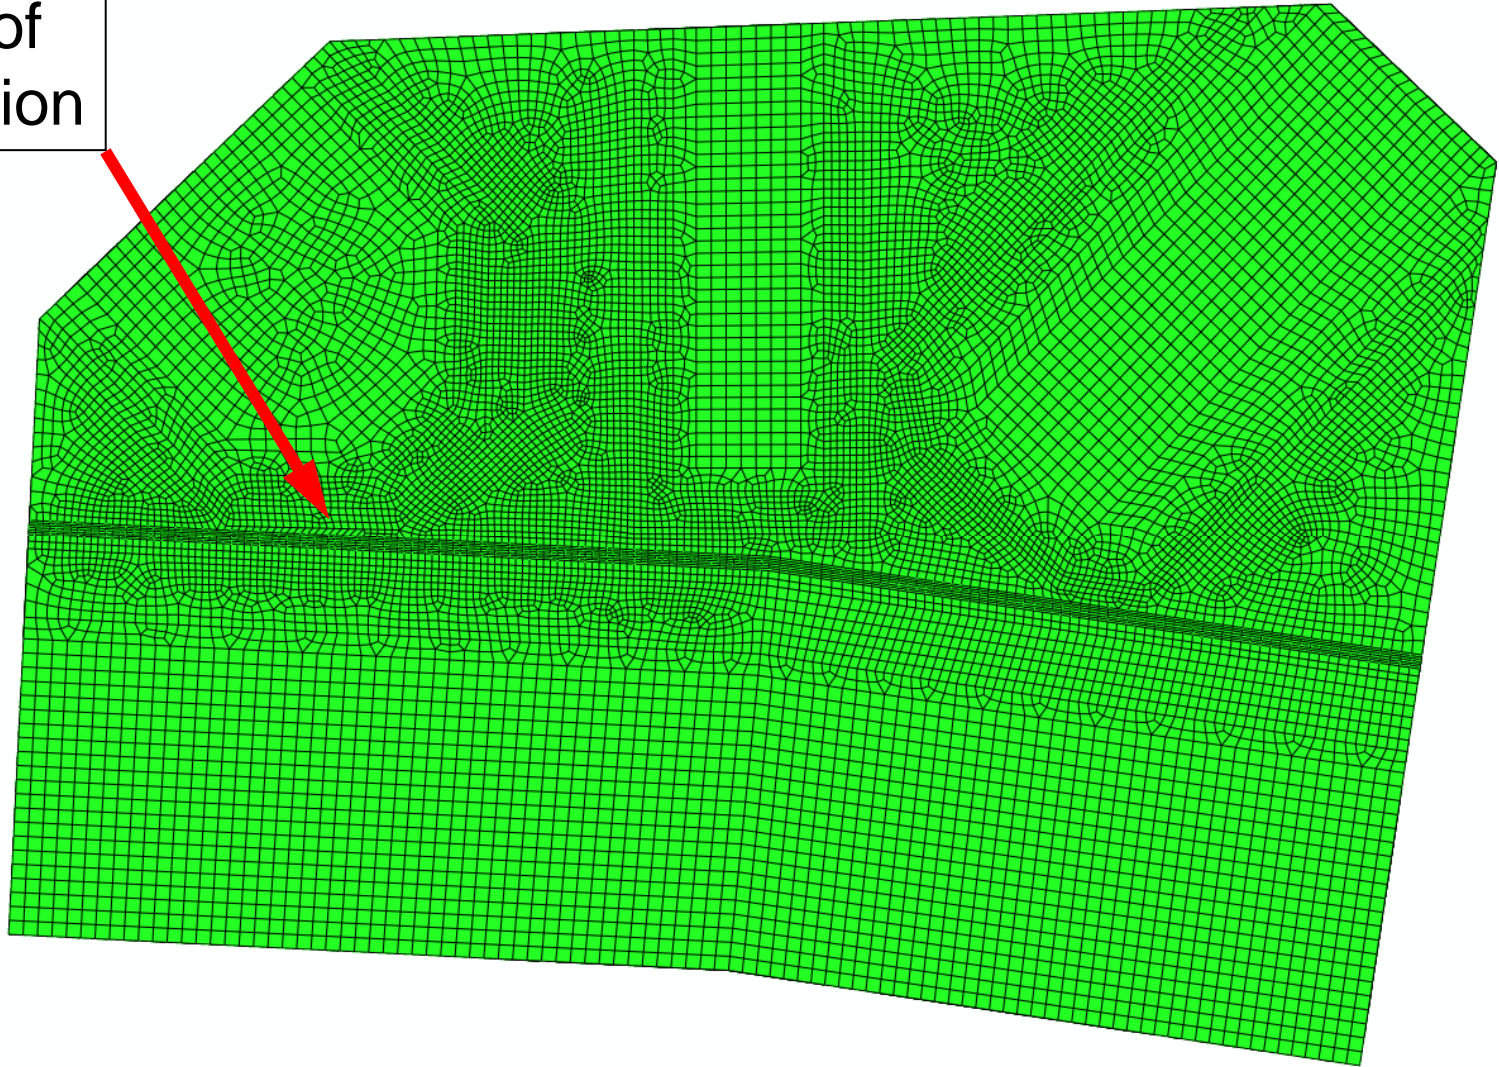
# Model of L11 with Corrosion

Band of  
corrosion

- Did not affect loads at U10 West
- Did not alter load that triggered instability at U10 West
- Able to support much higher applied loads than those that triggered instability at U10 West
